Beach Erosion Mitigation and Sediment Management Alternatives at Wallops Island, VA

Andrew Morang, Gregory G. Williams, and Jerry W. Swean

September 2006

Final report

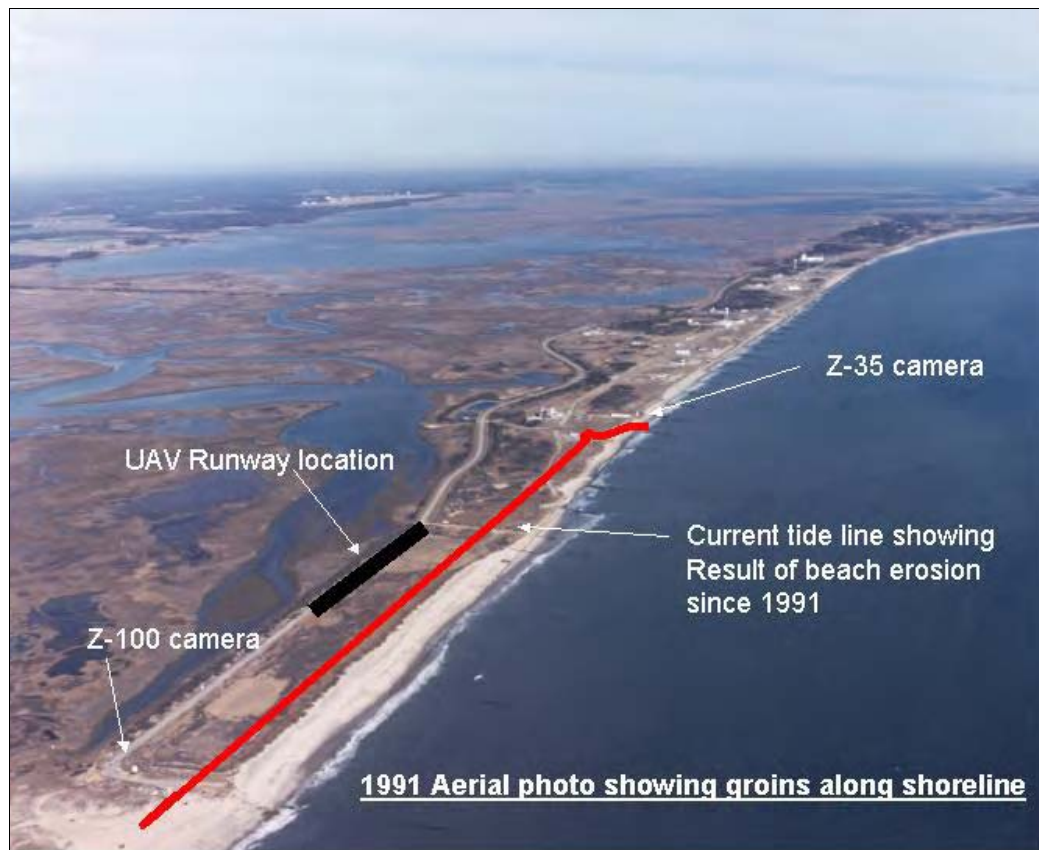
Figure 5. Oblique 1991 aerial photograph of south end of Wallops Island showing approximate position of 2005 shoreline. Photograph courtesy of Goddard Space Flight Center.

From 1857 (the date of the first USC&GS shoreline) to 1994, the southern part of Wallops Island has retreated about 400 m (Figures 4 and 5). Based on this 1857 survey, the shoreline retreat rate near Pad 0B has been about 3.7 m/year, while further south, near Assawoman Inlet, the rate increased to ≈ 5.5 m/year. When using the USC&GS 1911 survey, the retreat rate near Assawoman Inlet was less, about 2.5 m/year. The reduction might be natural, due to a change in storminess or possibly because of the sheltering effect of the growing Fishing Point. It may also be a mapping artifact, depending on what feature the surveyors mapped in the field or positioning error.

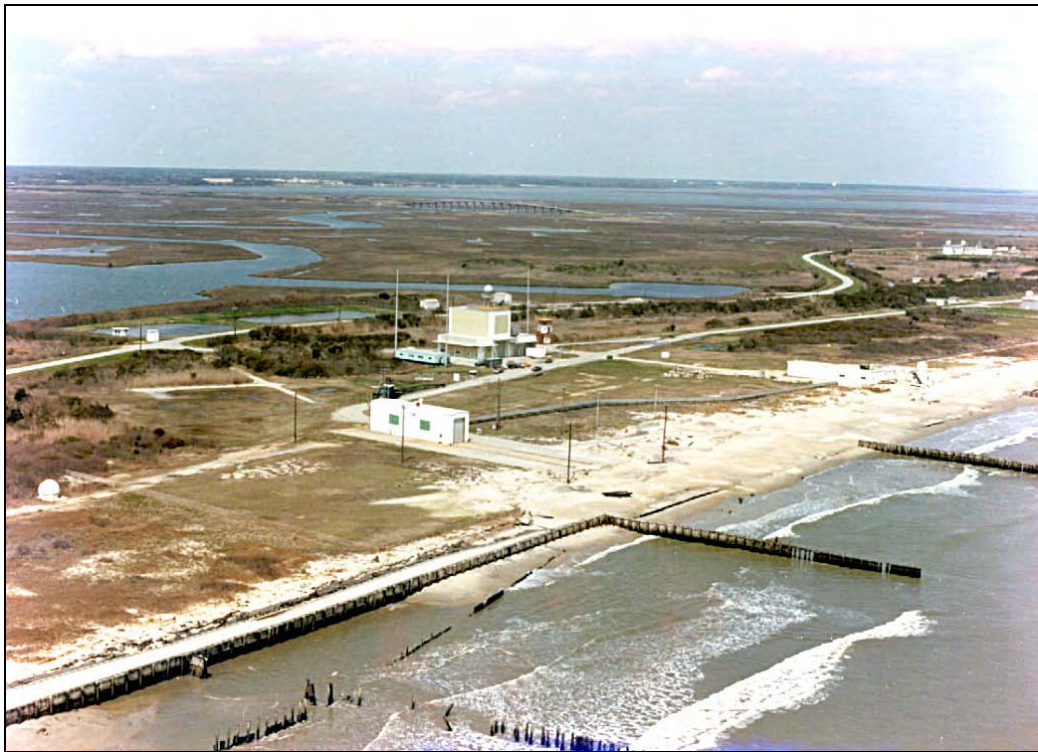
Figure 10. 1983 view taken in same area as Figure 7. Part of wood seawall has collapsed. NASA photograph 83-102-14, courtesy of Goddard Space Flight Center.

The fundamental reason that many sections of the wood seawall failed was that it, too, was dependent on the existence of a protective beach strand to prevent waves from undermining the toe.

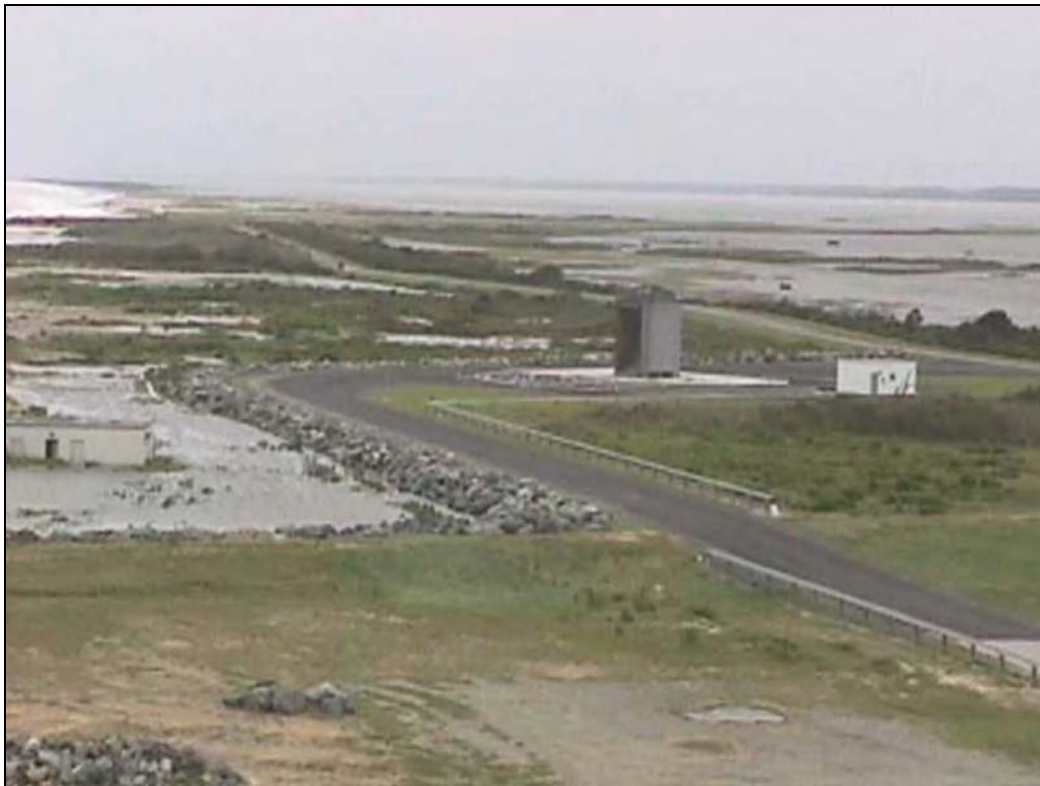
Figure 15. South end of Wallops Island during Hurricane Dennis (photograph taken approximately 1-4 September 1999. Standing water has reached the revetment in front of Pad 0B.

During a site visit in March 2006, it was observed that the crest of the seawall was irregular in height and stones had fallen into the shallow water on the ocean side. Along some areas, sand has been scoured from behind the structure, forming depressed areas that have standing water. M&N (1998) noted that this was already occurring in the late 1990s, as sand was progressively lost from the system. Photographs taken during Hurricane Dennis show significant standing water behind the seawall (Figures 14 and 15).

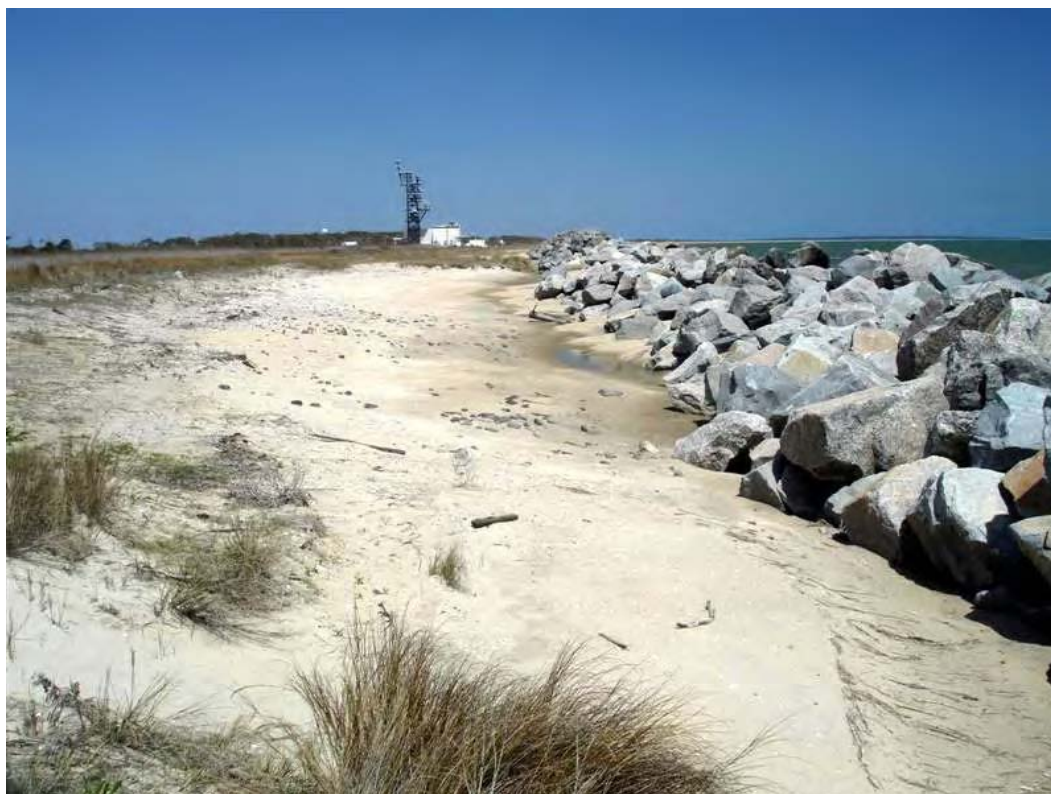
Figure 21. View north from U.S. Navy Aegis facility (Building V10/V20) toward Building V-24, 18 April 2006. Sand has been lost through seawall, and lowest areas contain standing water even on a calm day.

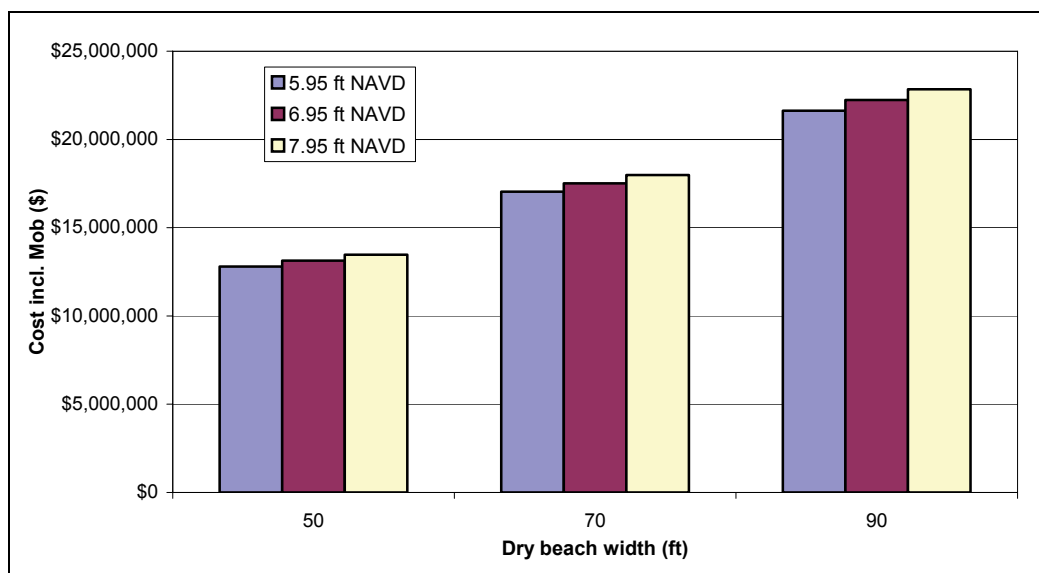
Figure 25. Assumed cost of beach fill at Wallops Island for various width and height beaches. Length of shore protected = 6,800 m (22,500 ft). Cost based on \$6/cu yd and depth of closure = -8.5 m (-28 ft).

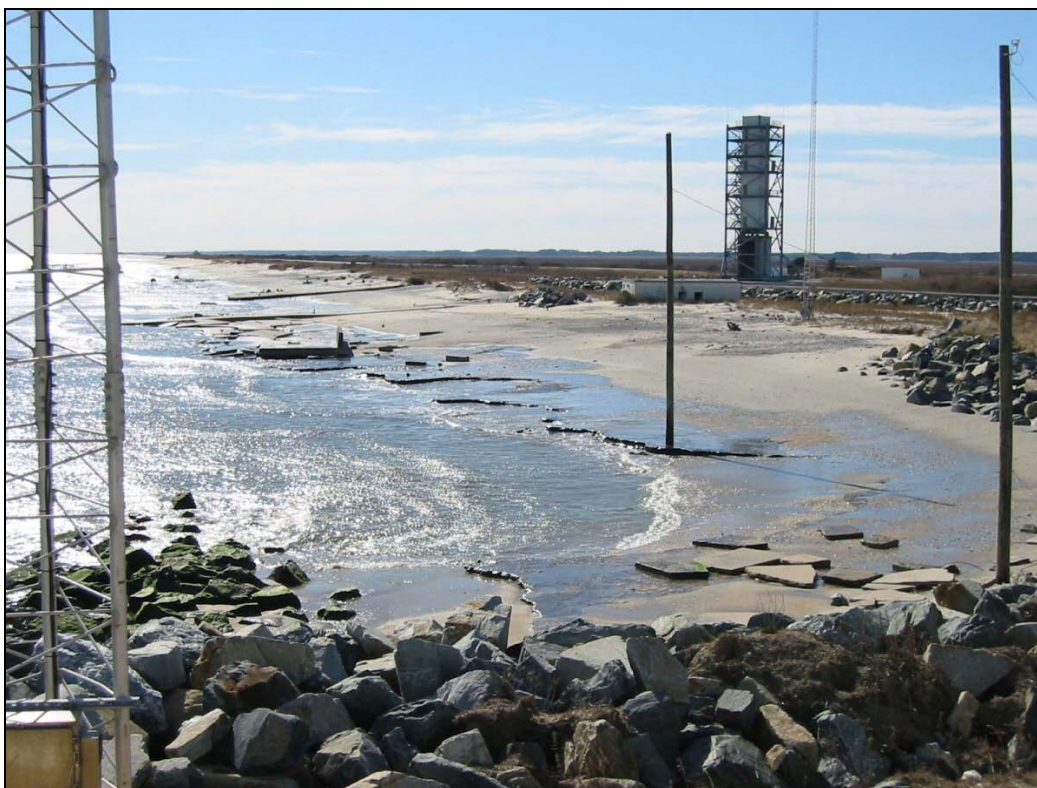
Figure 32. The MARS space flight facility (tower in upper right) is located just south of southernmost limit of seawall. Concrete rubble in surf zone is debris from former launch pads (photograph, 11 February 2005).
